SECTION 1. EXECUTIVE DIGEST

1.1 BACKGROUND

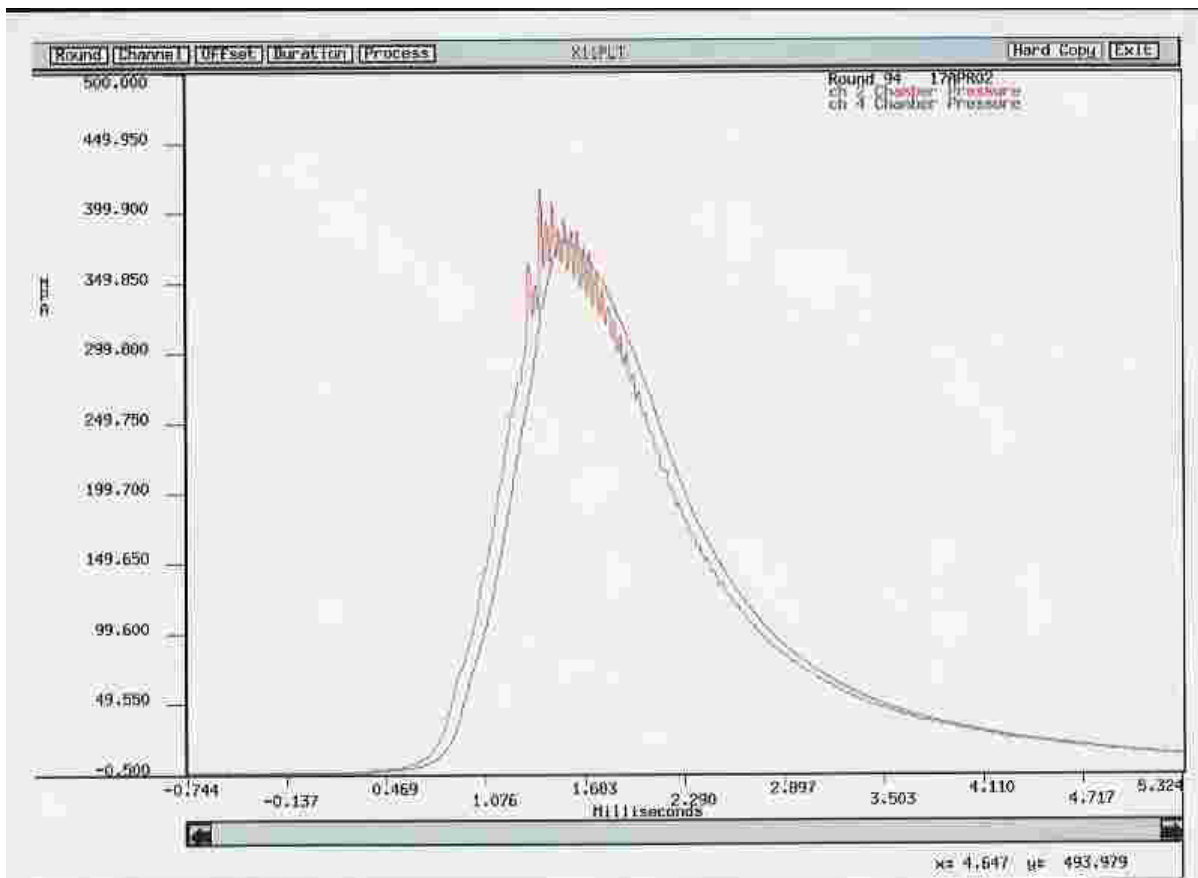
Despite use of the recommended pressure port, Helmholtz resonance was present which forced the ballistics technician to subjectively estimate the actual peak pressure.

Figure 5. Pressure trace from unfiltered charge amplifier output showing 20 KHz Helmholtz Resonance or “ringing” beginning just prior to peak pressure. Successive attempts at filtering out the 20 KHz “ringing” led to an optimal level of filtering at 5 KHz. This figure shows the original pressure trace side by side with the filtered pressure trace.

Filtering was tried at four different levels (20 KHz, 10 KHz, 5 KHz, and 1 KHz) to reduce the effect of “ringing” until an optimum filter level was found at 5 KHz. All subsequent testing was accomplished using a 5 KHz filtered signal to report peak chamber pressure. Based on the success with this approach to eliminating Helmholtz Resonance, a 5 KHz filter will be used in subsequent 25mm testing with the Kistler Model 617 Transducer.

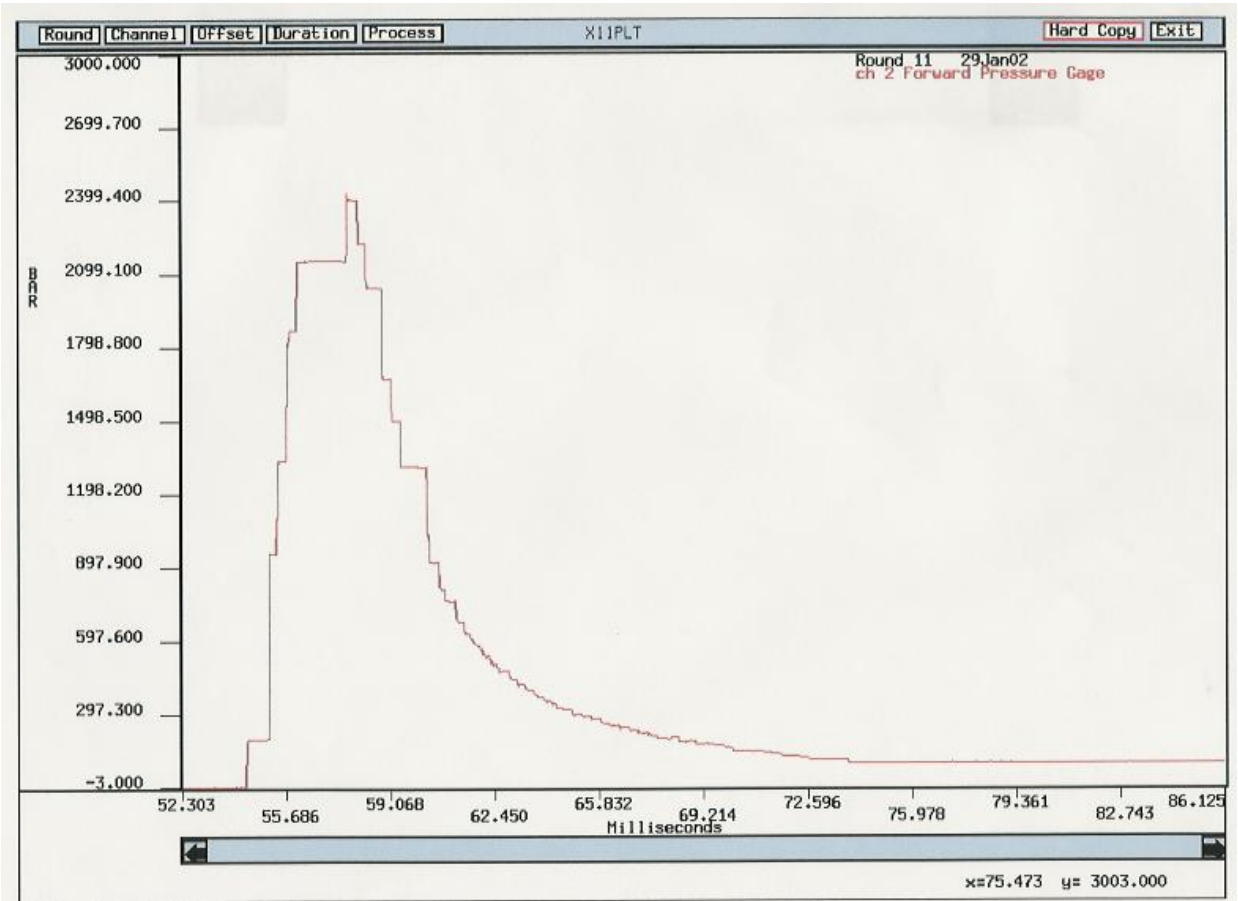
During testing of a 90mm Cannon in February 2002 a pressure curve exhibited a “stair-step” pressure trace. This type of trace is a result of the intermittent contact in the center conductor occurring during recoil when the Microdot cable is in motion. Without an electrical short present, the signal to the charge amplifier will bleed off leading to a flat line, on a millisecond scale, until contact is re-established and the next level of charge is sensed leading to a trace that resembles a staircase. The problem is quickly rectified by replacing the problematic Microdot cable for the affected channel.

Figure 6. “Stair-step” trace characteristic of intermittent contact in the Microdot cable center conductor.

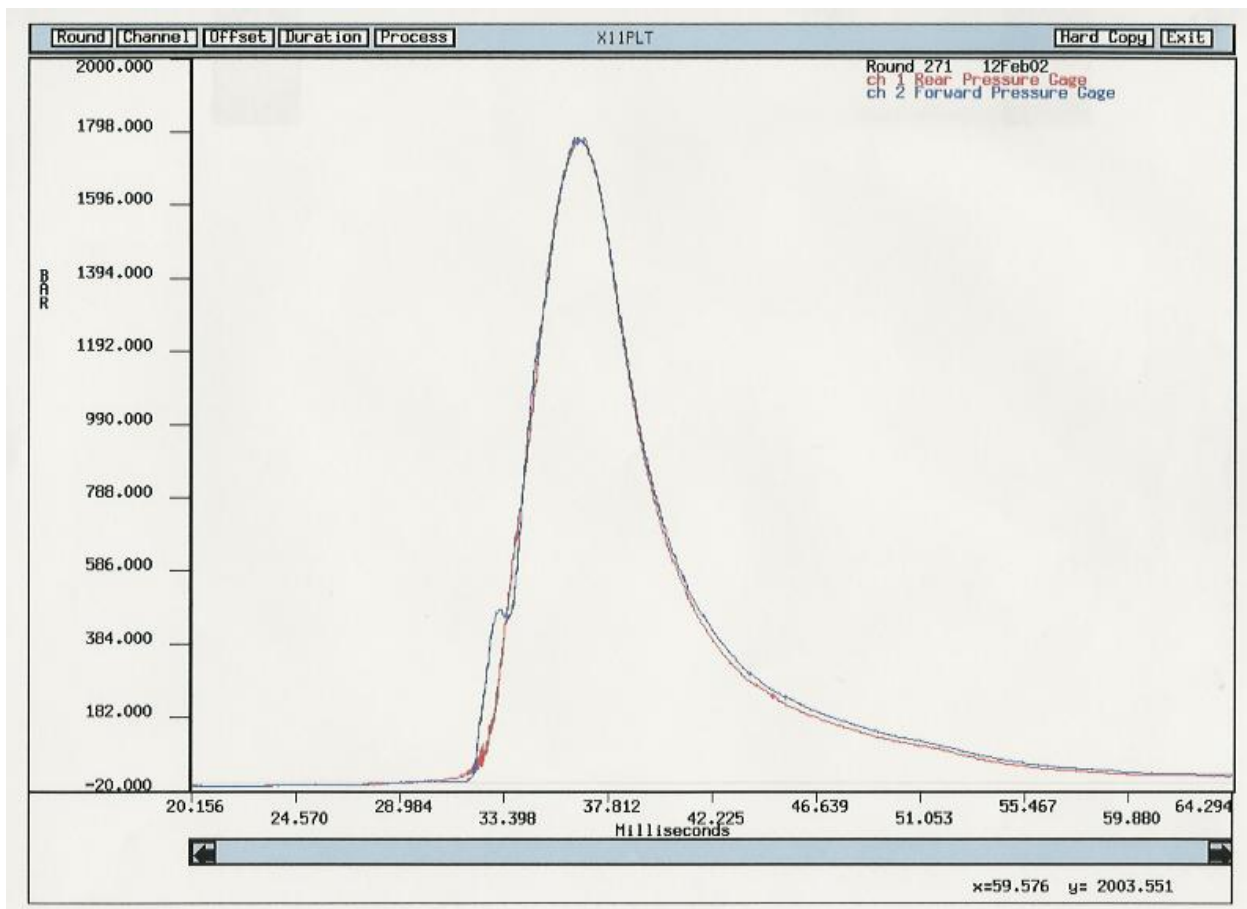
Figure 7. Small secondary peak created by pressure loss during blow-by at the pressure port until cartridge case sealing is restored by increasing pressure inside the case.

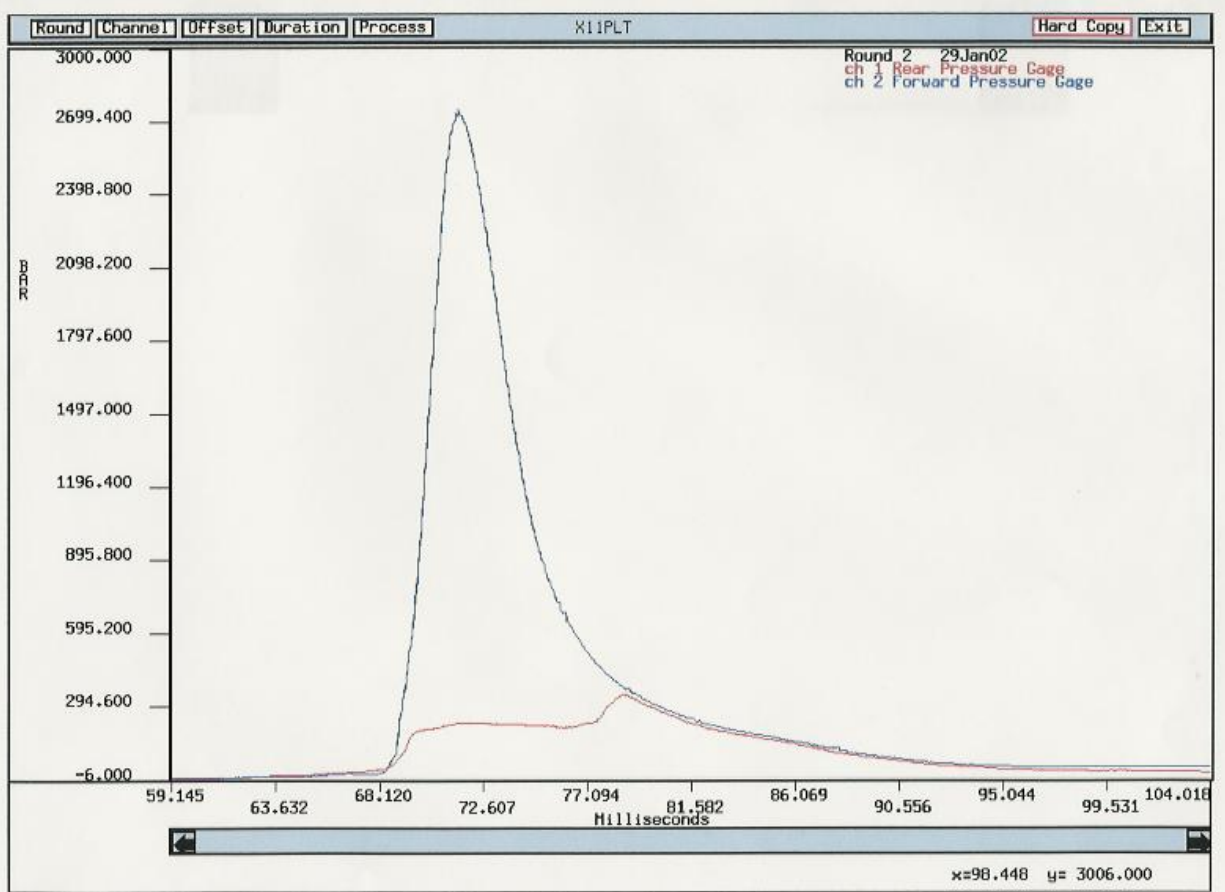
Figure 8. Truncated rear chamber pressure trace caused by misalignment of cartridge case with pressure port. The points where the curve deviate from and return to a normal profile are caused by the sealing and unsealing of the cartridge case against the chamber wall.

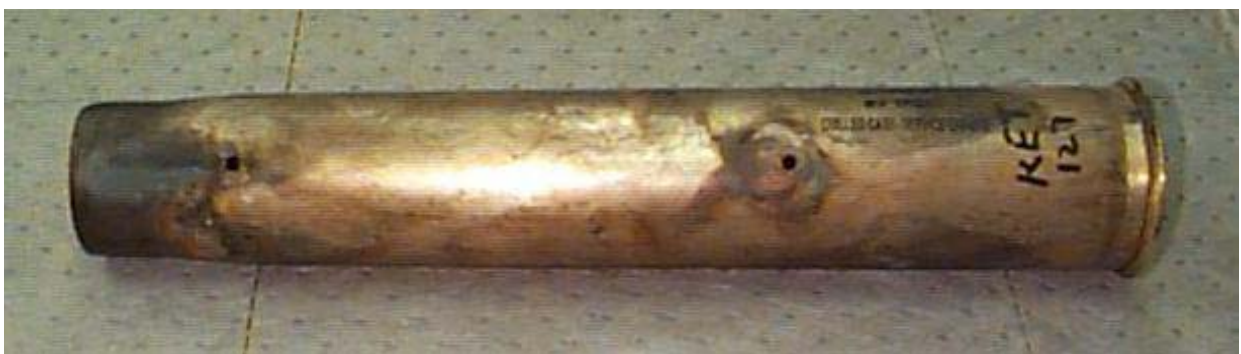
Figure 9. 90mm Cartridge case drilled for pressure ports. Note tarnishing of metal around pressure port locations and at the projectile crimp area caused by lack of case sealing and blow-by. This will eventually lead to erosion in the chamber wall leading to additional errors in pressure measurement.

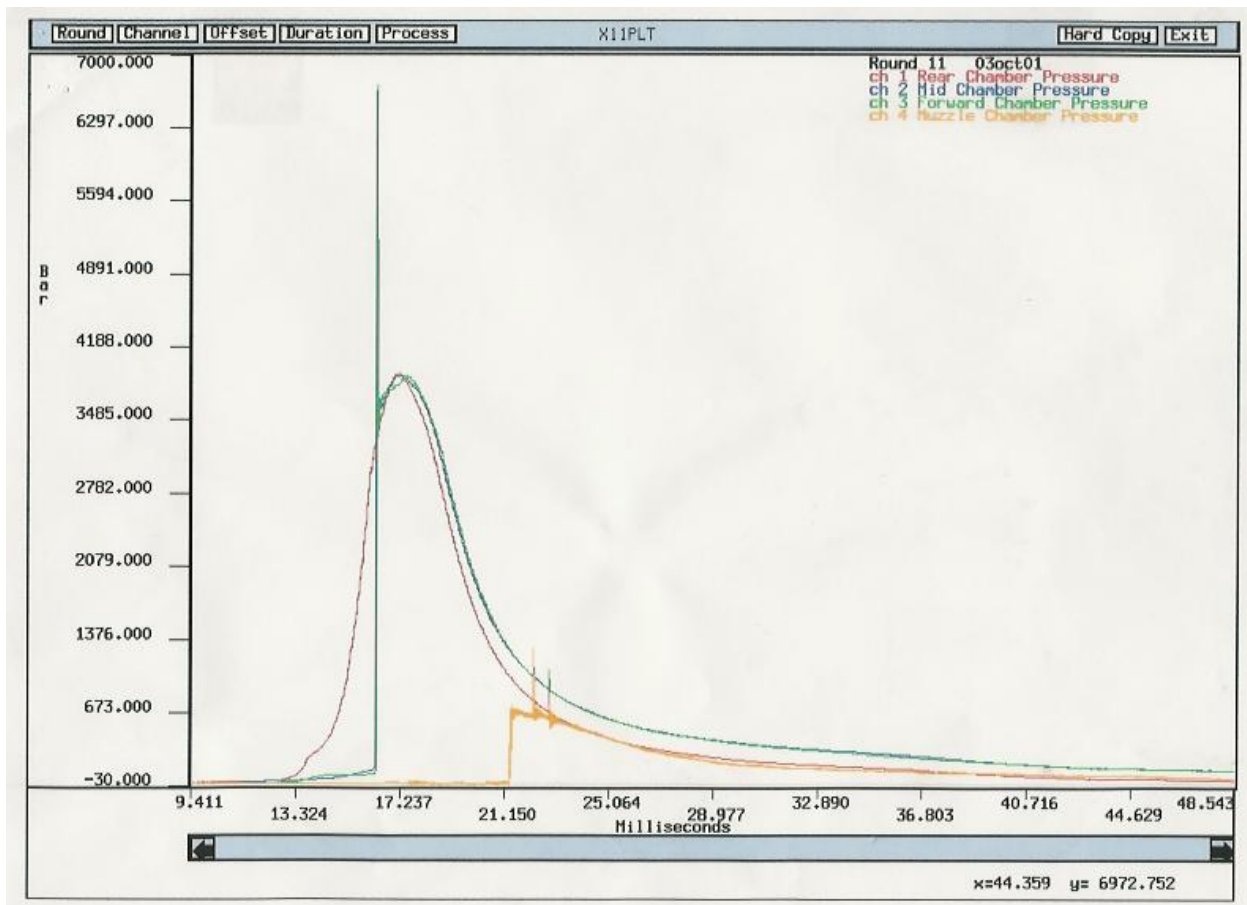
In a developmental 105mm Cannon, a new design cartridge case featured plastic and metal construction and was intended to survive and be ejected from the gun after firing. Pressure ports were located at mid-chamber locations but did not have corresponding holes drilled in the plastic case. As a consequence, pressure built-up inside the cartridge case and punched holes through to the pressure port. This caused a small block of cartridge case material to impact against the sensing element of the transducer leading to a spike in the pressure trace on the affected channels. Repeated exposure to this type of event eventually led to destruction of the transducers.

Figure 10. Spike affecting two channels of data caused by cartridge case material impacting on the pressure sensor.

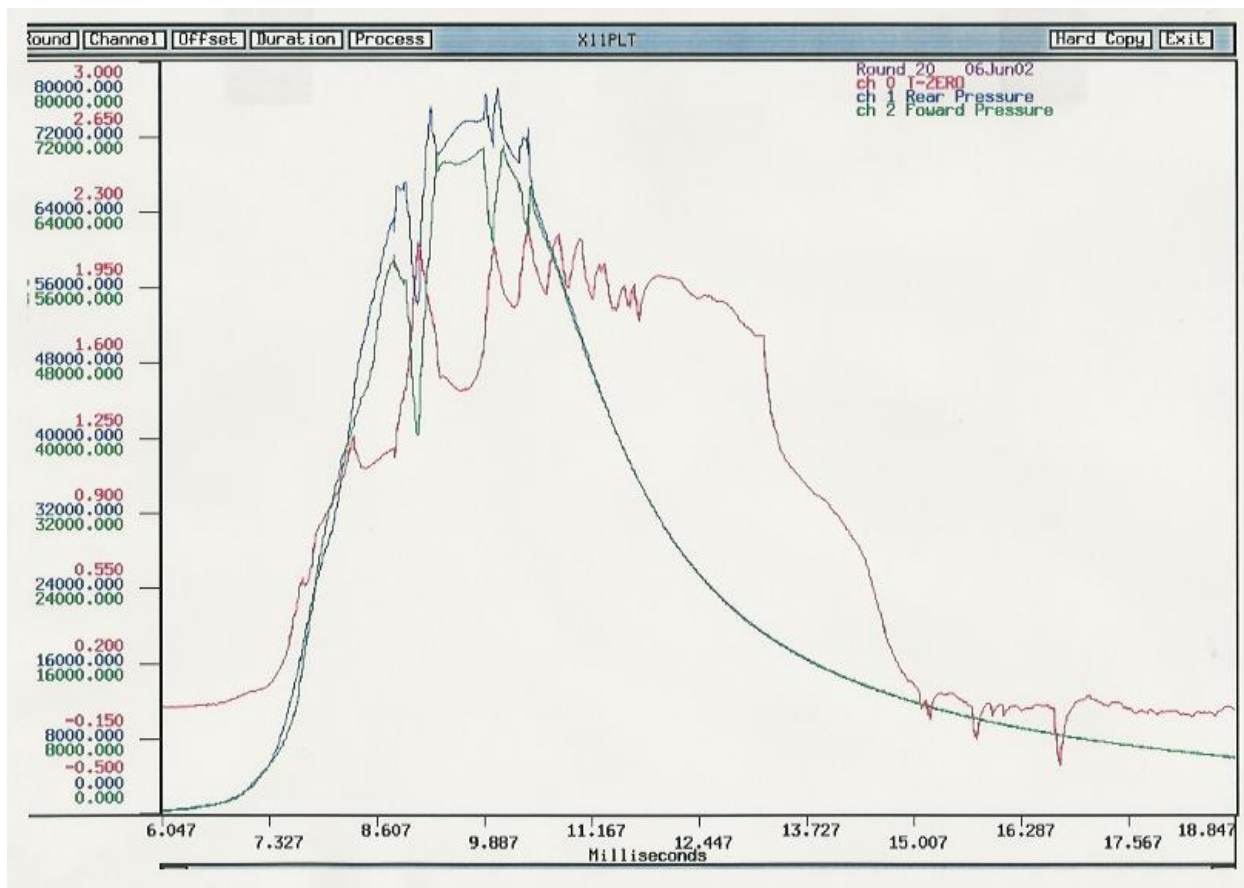
During 120mm testing, drop outs were observed in the normal smooth curve of the pressure trace. Because the drop outs affected both channels of the data it was suspected that the cause was electrical in nature. Eventually a comparison was made to the line carrying the firing pulse and a corresponding post-ignition negative voltage spike was observed to coincide with the drop outs on the pressure curves. The problem was attributed to grounding with the weapon.

Figure 11. Simultaneous graph showing overlay of firing circuit voltage (channel 0) and forward (channel 2) and rear (channel 1) pressure channels.

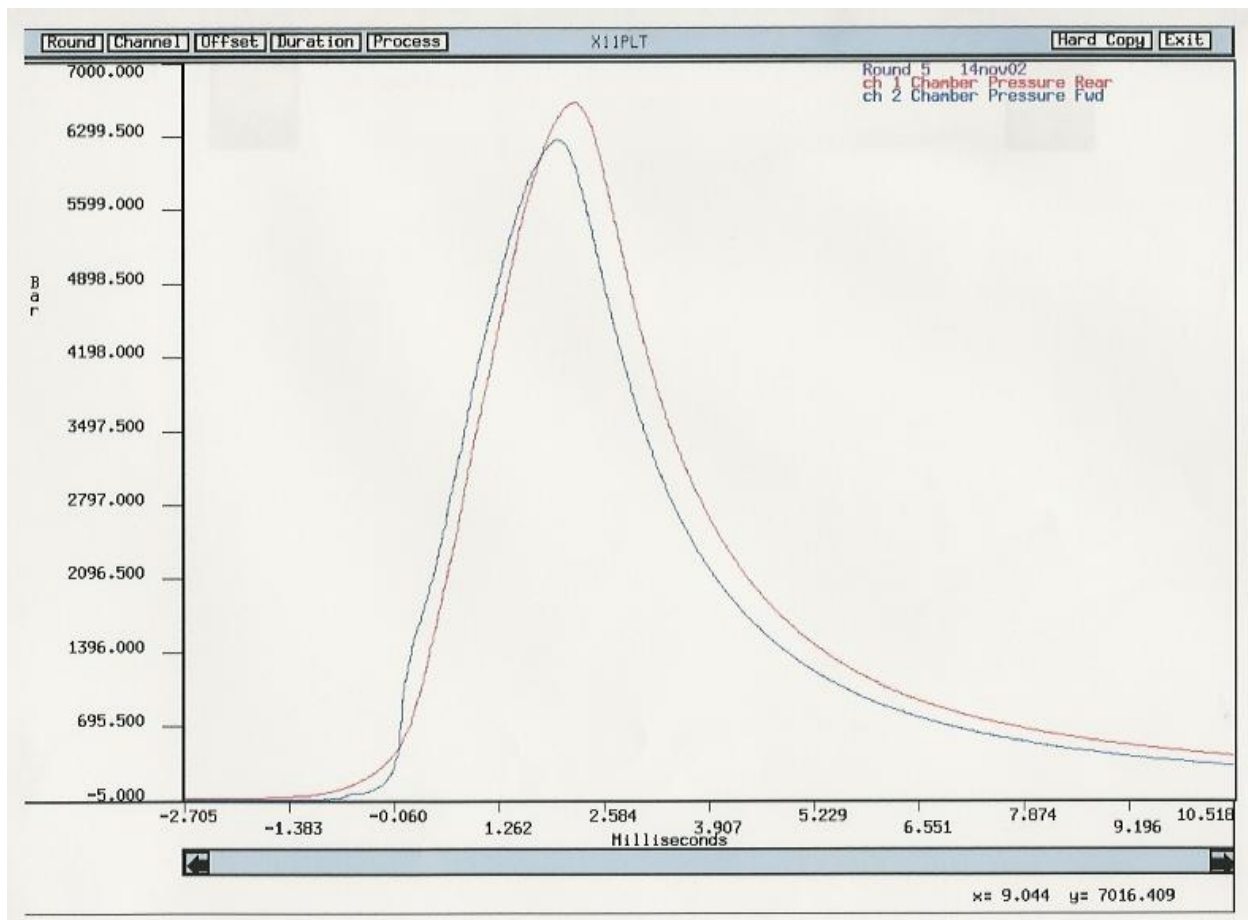
During 120mm testing of a developmental round, a 1000 Bar negative differential pressure was observed. A differential pressure of this magnitude is cause for concern since it can lead to break up of propellant grains and detonation leading to physical damage to the cannon. The propellant had been recovered for re-use from previously manufactured tactical rounds; consequently propellant aging was a real concern. A review of instrumentation causes that might lead to a phase shift was undertaken by the ballistics technician. A capacitance meter was used to check differing levels of capacitance in the front and rear channels. Readings of 1995 and 1989 picoFarads were obtained; the difference between these two values was deemed too small to explain the phase shift. A Time Domain Reflectometer was used to check the condition of the cables leading out to the transducers. A graphic display of the cable condition and location of splices or connections revealed no cable problems. The use of this particular instrument can be very valuable in gauging the integrity of long lengths of cable for opens or shorts and may become a regular requirement for ballistics testing. Ultimately the ballistics technician identified parameter settings in the Ballistics Test Site software that could lead to a phase shift. Channels are setup either as a "Slave" or "Master" to establish a trigger order. Standard practice is to have one primary "Master" (typically firing circuit voltage) and a backup "Master" (typically the rear chamber pressure gage). When the threshold voltage is reached for either "Master" channel, data begins being recorded, and the "Slave" channel(s) begin recording at the moment of "Master" trigger. Without a "Master trigger", the "Slave" channels will not record any data. On this particular occasion, each pressure channel was set as a "Master" with no corresponding "Slave". The net result was that each pressure channel would trigger independently once its threshold voltage was reached. When the data was submitted to the plotting routine the time axis for each curve would be automatically be aligned to zero and a phase shift would be induced. Once the cause was identified, the parameters were re-set so that the forward channel became a "Slave" of the "Master" rear channel.

Figure 12. Phase shift leading to an apparent excessive negative differential pressure. A check of the Ballistics Software parameters revealed that each channel was acting independently as a “Master”. Slaving the forward channel to the rear linked the previously separate events and eliminated the phase shift.

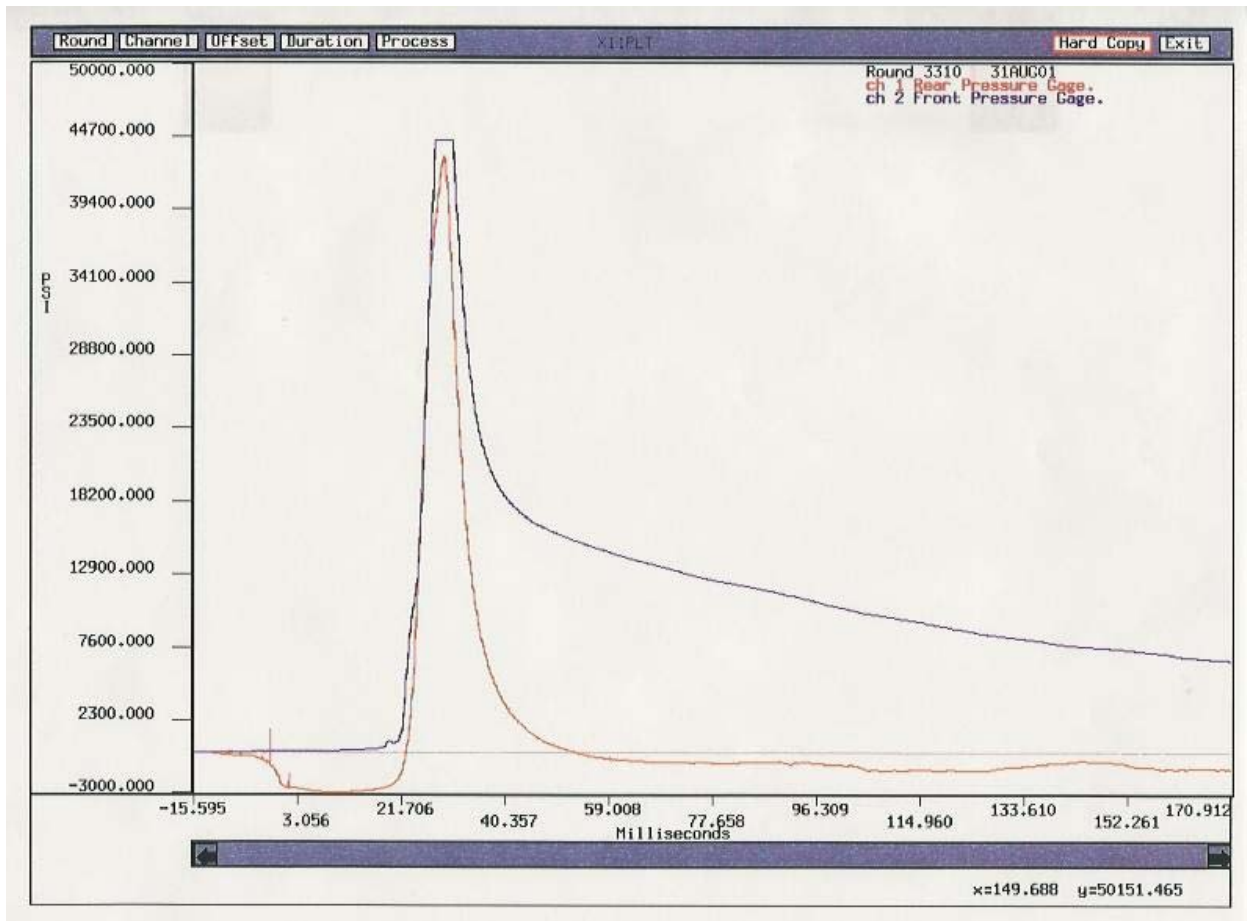
During the firing of a 175mm cannon recurring pressure reversals were seen in the pressure traces. The 175mm cannon employs a spindle to seal the rear of the chamber. The spindle is drilled to accept a Microdot cable and has two threaded holes for attaching an adaptor containing the pressure transducer. A Kistler Model 607C Pressure Transducer was installed into the adaptor. The adaptor was held in place on the front of the spindle by two 1/4-28 Socket Head Cap Screws which were torqued in place by hand. A large full face copper seal was used to provide the pressure sealing between the adaptor and the cannon spindle. Physical examination of the spindle showed scorching and propellant residue behind where the adaptor pressure seal was located.

Figure 13. Lower than expected rear pressure caused by inadequate pressure sealing between the adaptor holding the pressure transducer and the spindle. Propellant gases were able to escape behind the transducer leading to a localized lower rear pressure. Note the “clipping” of the front channel – this is caused by setting too low a Peak Pressure parameter leading to an out-of-measurement-range condition for the data acquisition software.

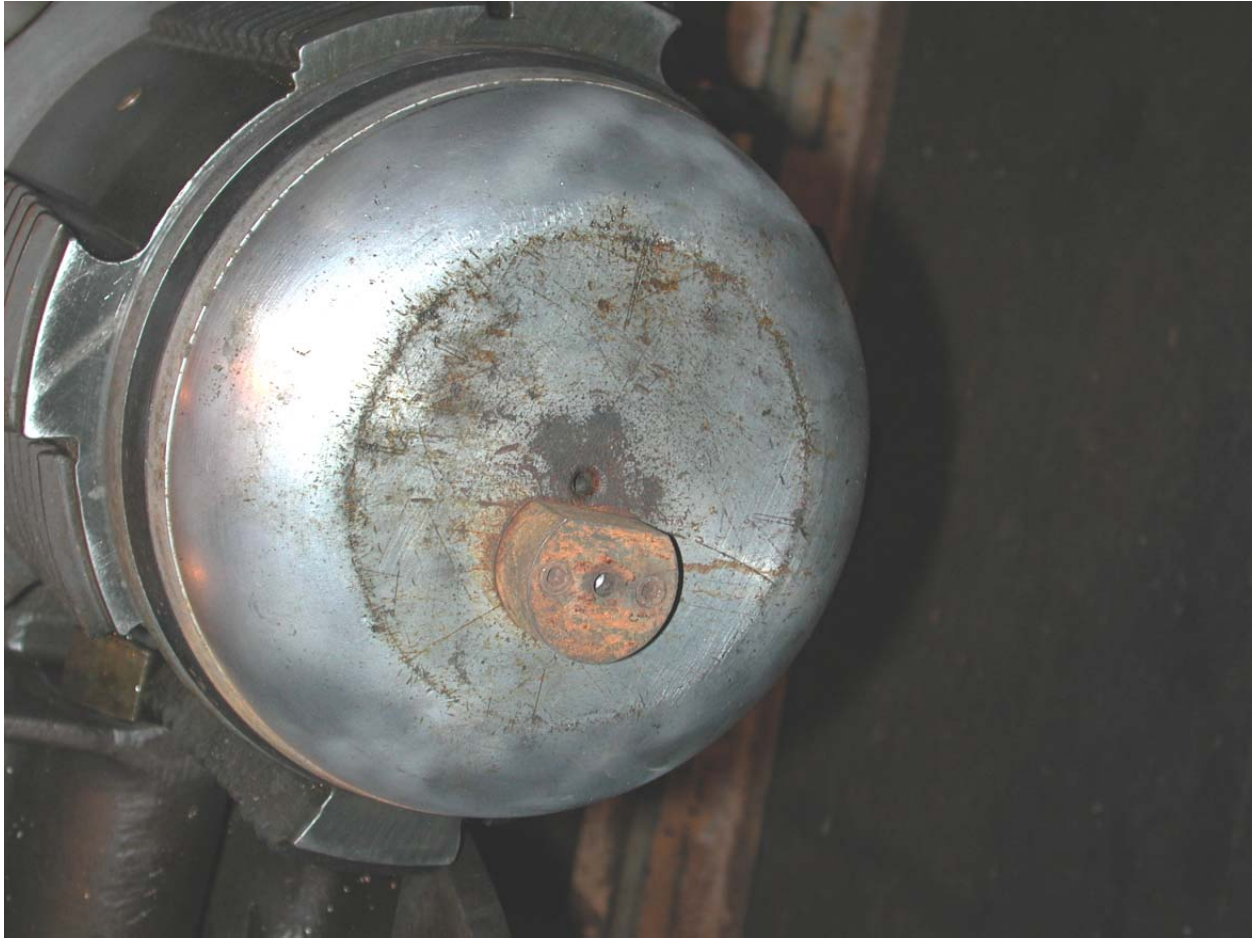
Figure 14. Assembly of pressure transducer adaptor to 175mm spindle. The adaptor is held in place by hand tightening two $\frac{1}{4}$ -28 socket head cap screws. Hand tight torque on these two screws is inadequate to compress the full face pressure seal behind the adaptor leading to propellant leakage behind the adaptor and lower than expected rear chamber pressure.

The transducer adaptor design can be improved by machining existing hardware or by fabrication of new adaptor body (preferred). First, the full face copper seal needs to be reduced in size to permit crushing and intimate contact following application of screw torque. This can be done by confining sealing to the diameter immediately around the transducer cavity. The seal itself would then become approximately $\varnothing.625$ inch. Matching 150° beveled surfaces would then be machined into the seal and corresponding sealing surfaces of the spindle and adaptor providing maximum compression of the seal during installation and especially during cannon firing. Specifying a 14 lb-ft torque level for 1/4-28 hardened alloy steel socket head cap screws would be required. Improved compression of the pressure seal would be obtained by adding a third screw to the adaptor assembly; the screws would be equally spaced for proper distribution of the clamping force during torque application.
